RE: Structural Condition Assessment  
8 Merrimac Rd, Newton, NH

SFC Project No. 639001

**8 Merrimac Rd, Newton, NH – Structural Condition Assessment**  
**Photo Index**  
**SFC Job No.: 639001**  
**September 25, 2015**

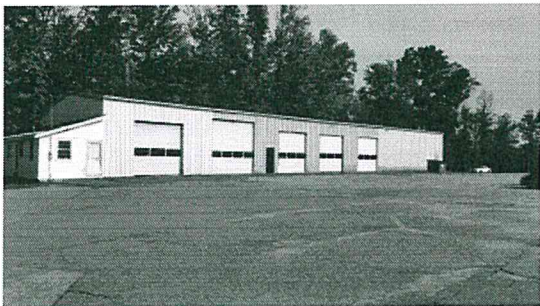
General view of existing building.
2

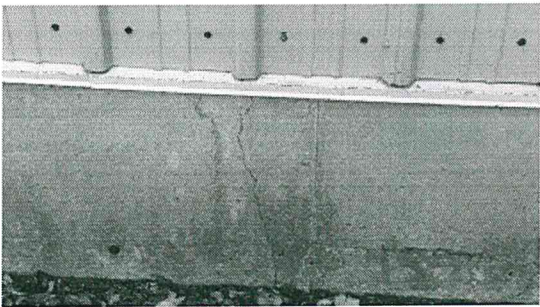
The exposed portions of the foundation wall are in good condition, with the exception of one pilaster located on the northwest elevation that has significant spalling. Several non-structural defects such as shrinkage cracks and honeycombing were also observed.

Typical crack in the exposed concrete stem wall.
3

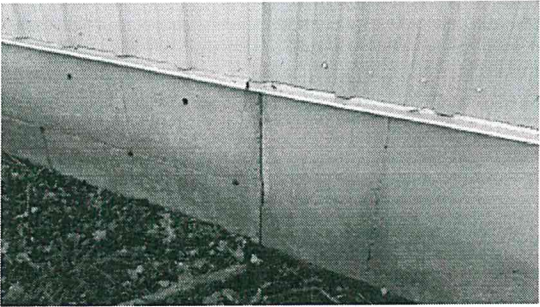
View of interface between the '74 and '84 additions.

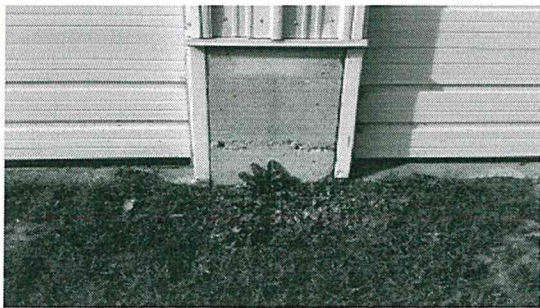
Honeycombing in the concrete stem wall.
5

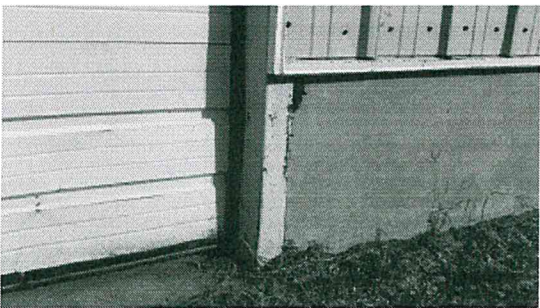
May of the overhead door jams have similar damage from prior vehicle impacts. The damage does not appear to have affected the structure of the building.
6

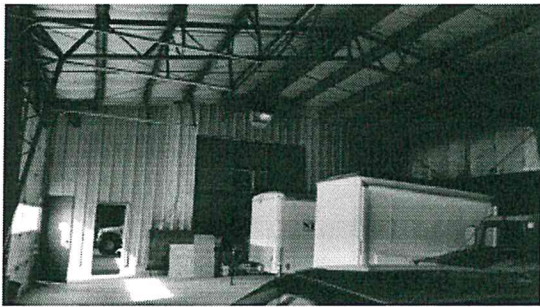
View of the interior of the '74 addition.
7

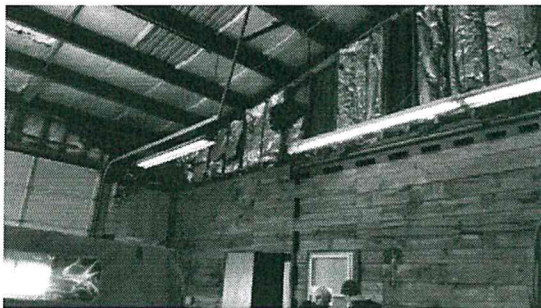
The condition of the wood framed addition was not assessed as this section was represented to be programmed for demolition if the project advances. However we did note that a portion of the bearing wall between the two sections is supported on steel framing while the remainder is supported at grade. This wall supports both the roof of the wood framed addition and the southwest most bay of the metal building. Therefore if the wall is removed, a portion of the metal building will need to be either temporarily shored or removed and reconstructed.

View of the interface between the prefabricated metal building and the wood framed addition. The Dashed lines indicated steel framing in the plane of the wall. The roof framing would need to be shored or removed when the wood framed addition is demolished.

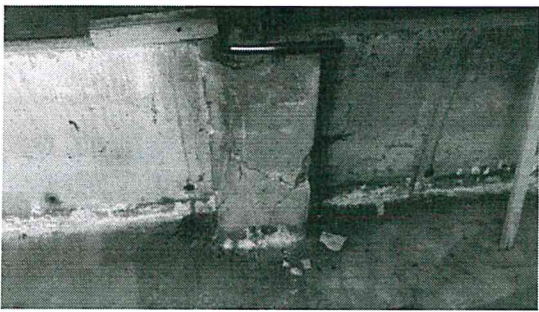
Spalled pilaster supporting one of the truss columns.
9

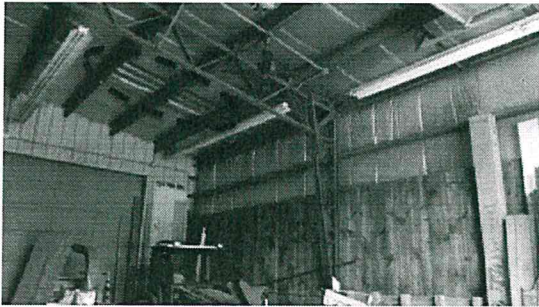
<p>Typical view of the interior of the '84 addition. Note the framing of the trusses differs from those in the '74 addition.</p> <p>Note a section of the insulated panel has been replaced with a metal roof deck (circled).</p>
10

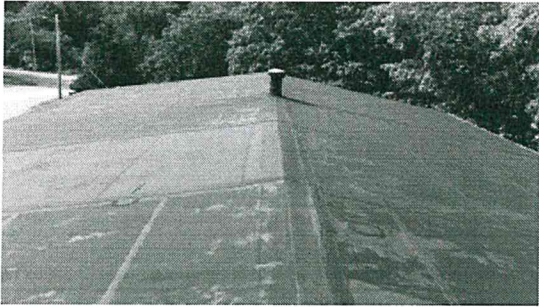
<p>General view of the roof of the prefabricated metal portion of the building.</p> <p>The EPDM appears to be in good condition. However some of the seams appear to be losing adhesion.</p>
