## Condition Assessment Report

### Newton Fire Station

35 South Main Street  
Newton, NH 03858

Prepared By:  
**Summit Engineering, PLLC**

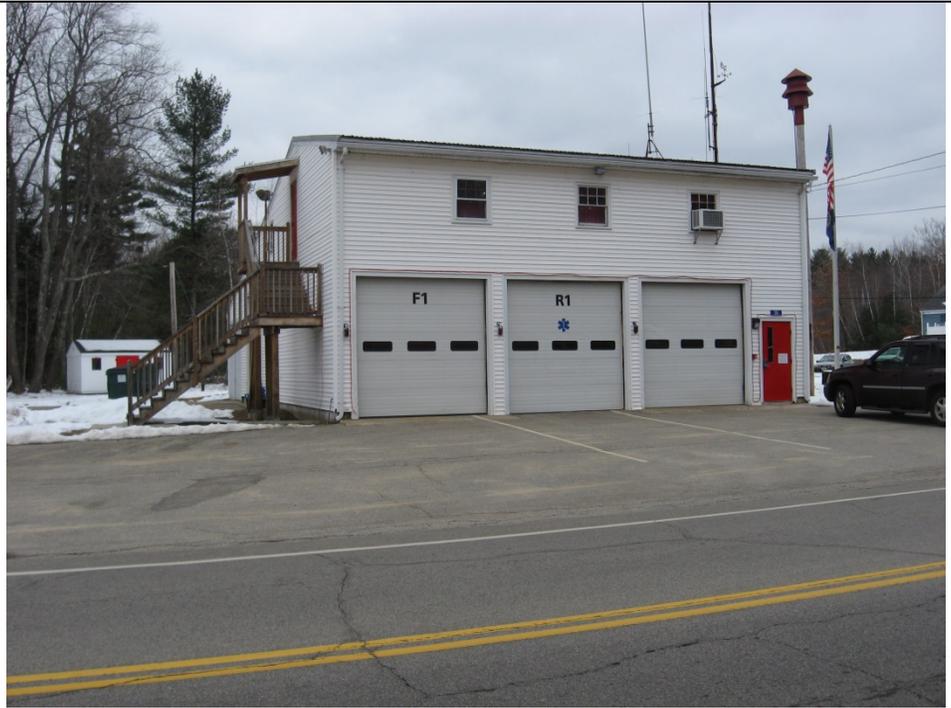
**Photograph 1 -**

Front of building, faces  
South Main Street  
(south orientation)

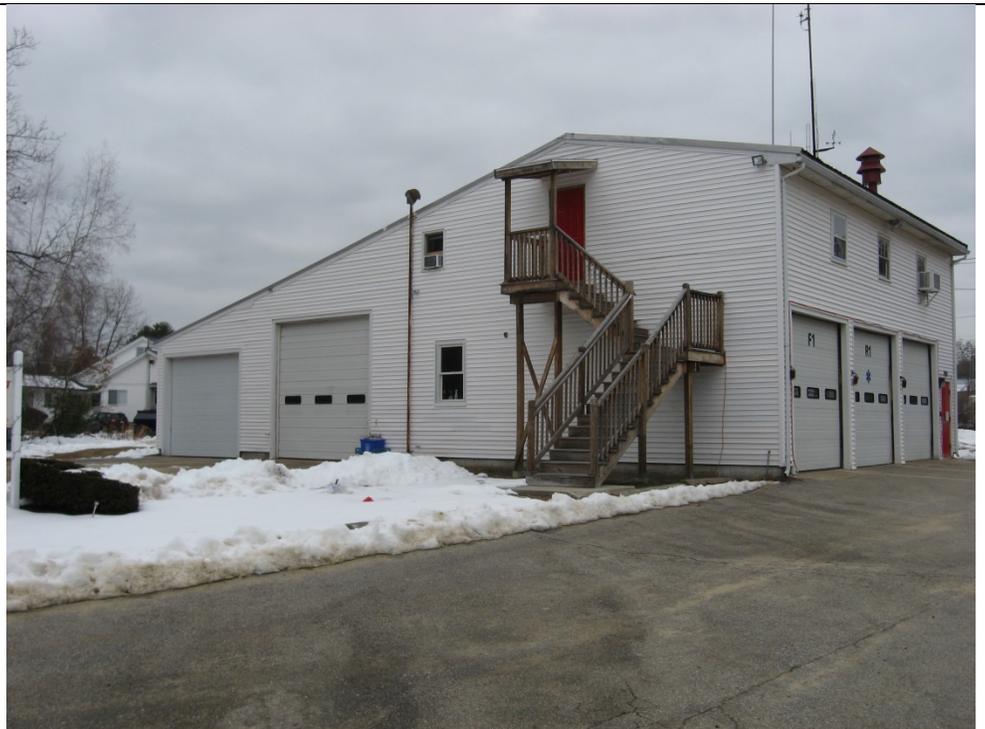
**Photograph 2 -**

There are two means of egress from the second floor: an interior stair that has second floor framing spanning over the stair at a dangerously low level; and a second means of egress is an exterior open wood stair. This exterior stair is mostly not covered with a roof as required. Both stairs are dimensionally correct regarding risers and treads.

Right side of building,  
(west orientation).

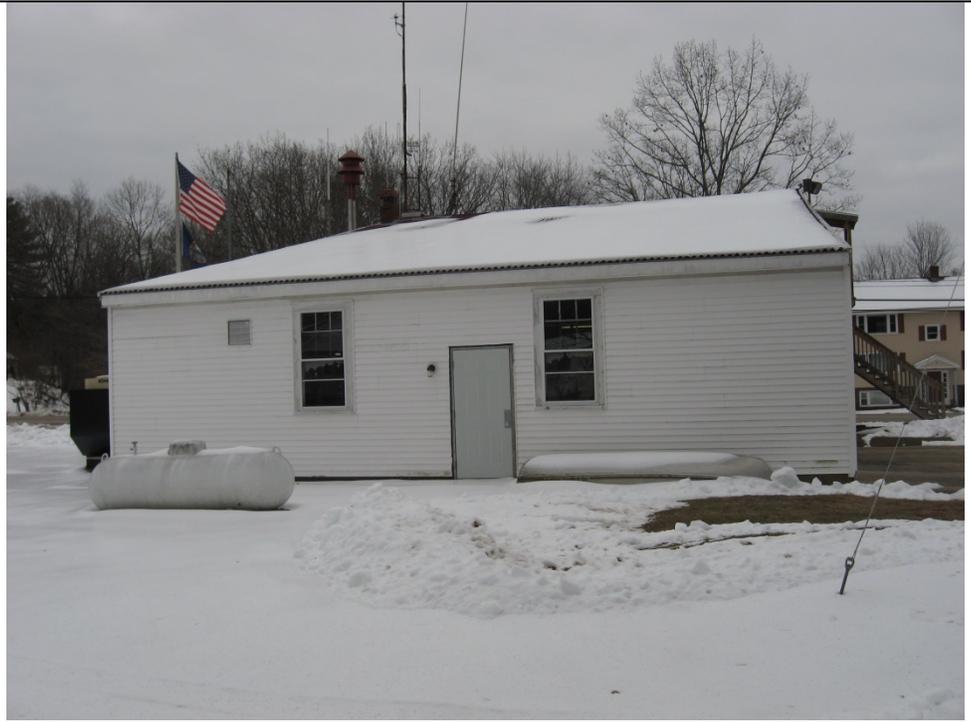
**Photograph 3 -**

Rear of building (north orientation)

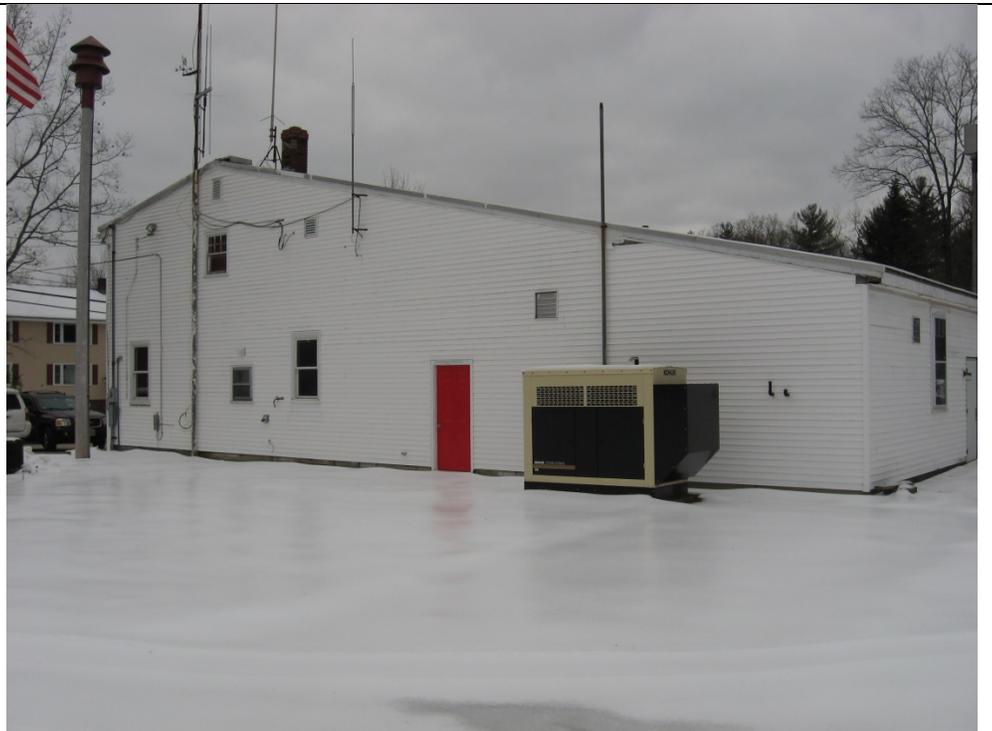
**Photograph 4 -**

Left side of building (east orientation)

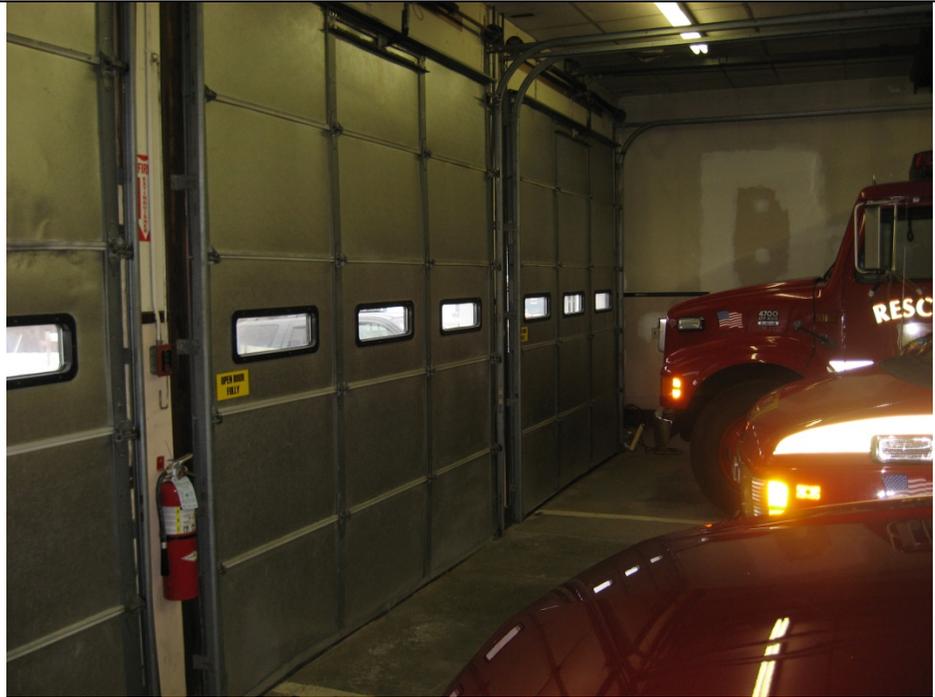
Photograph 5 -

As evidenced, the Apparatus Bays are extremely tight for space, circulation between walls and apparatus is limited and challenging for first responders. There is no required carbon monoxide building exhaust ventilation or a vehicle exhaust extraction system. The overhead doors are undersized for today's larger fire trucks.

Interior view of  
apparatus bay at front  
O/H doors

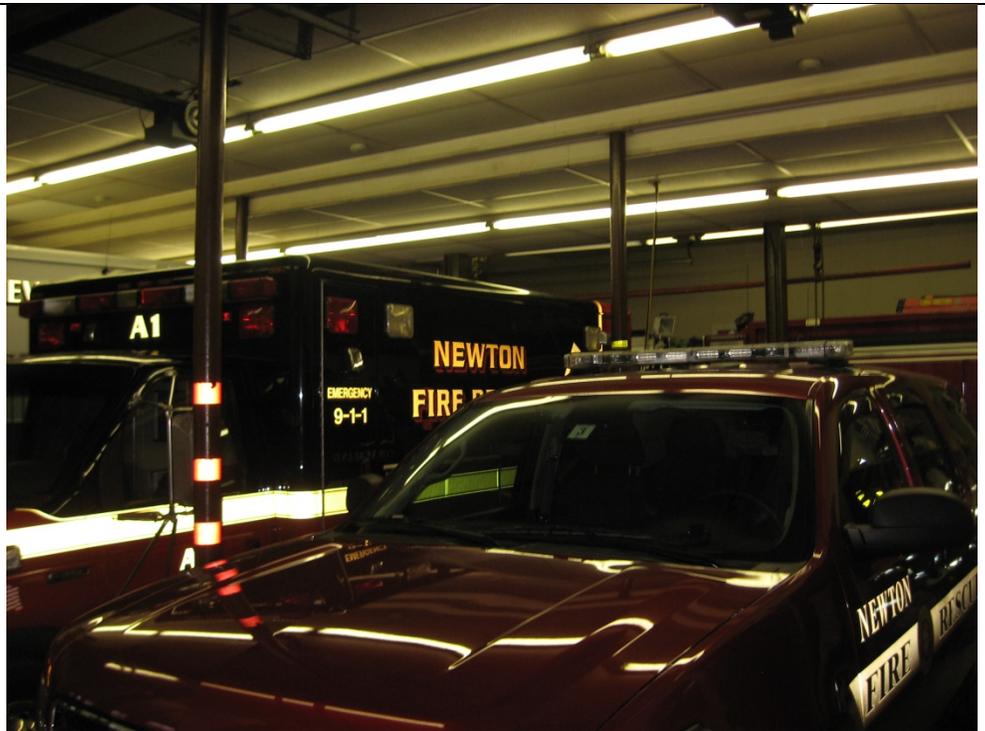
Photograph 6 -

Interior view of  
apparatus bay looking  
from front to back

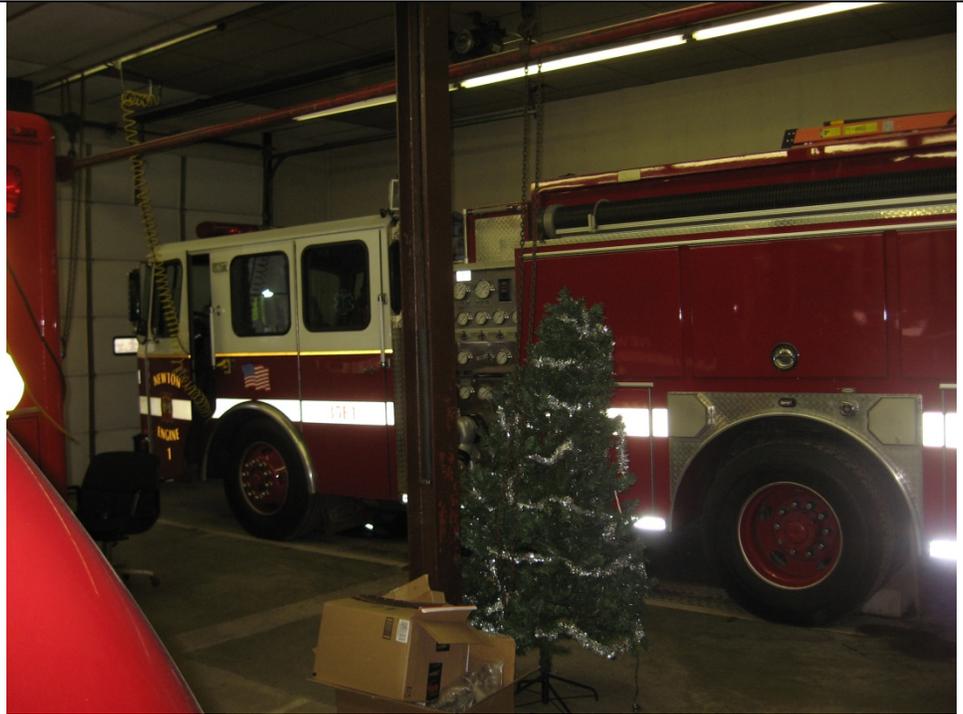
Photograph 7 -

Interior view at rear of apparatus bay (engine 1) looking towards right side O/H door

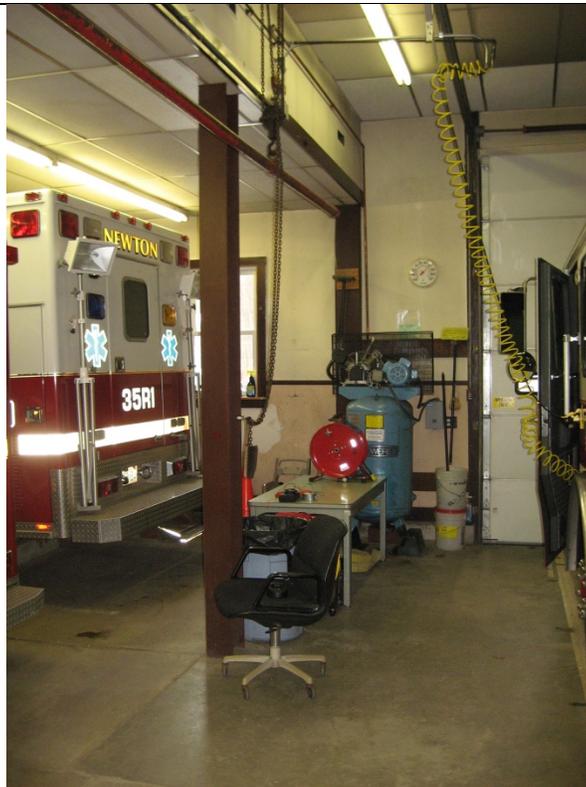
Photograph 8 -

Interior view of apparatus bay (engine 1 on right side of photo) looking towards right side O/H door

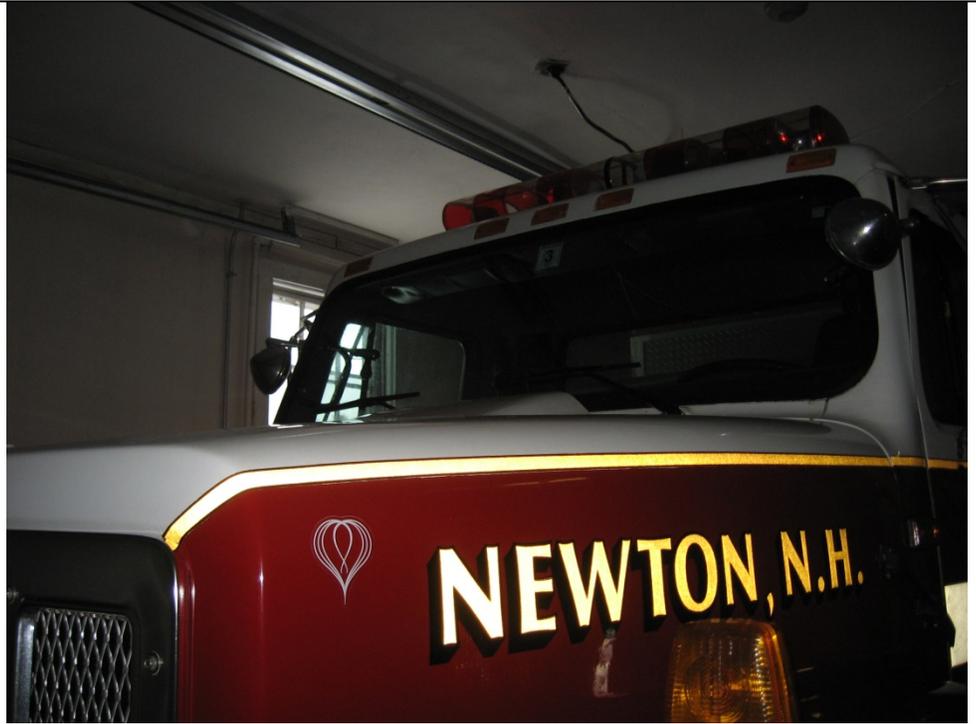
Photograph 9 -  
Interior view of tanker

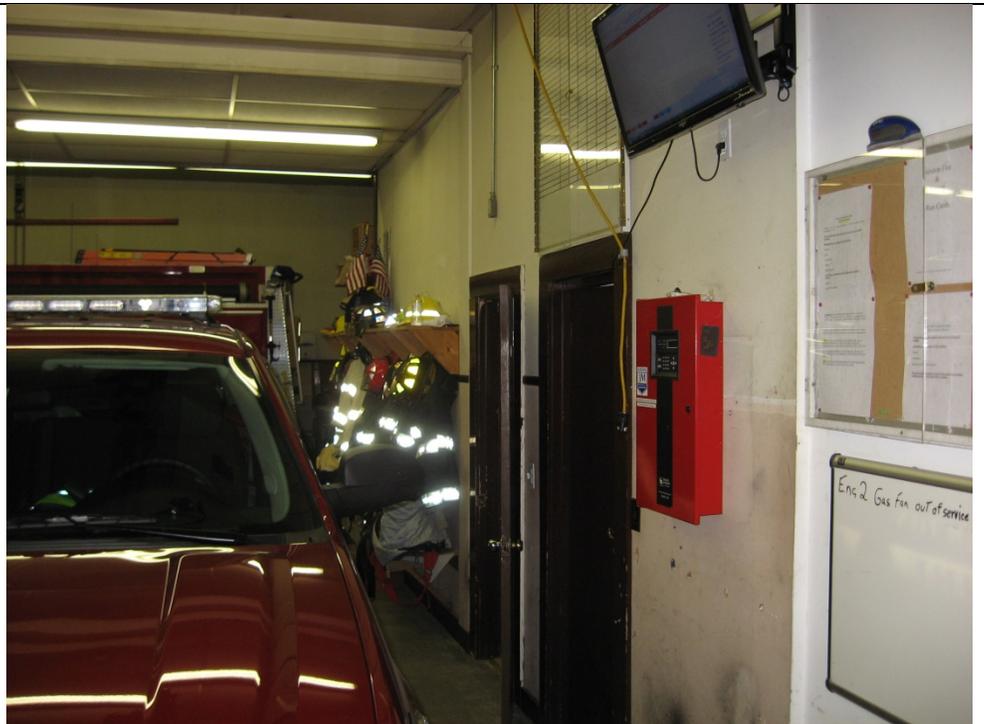
Photograph 10 -  
Interior view of  
apparatus bay (left  
side) looking from front  
to back, bathroom  
door on right side of

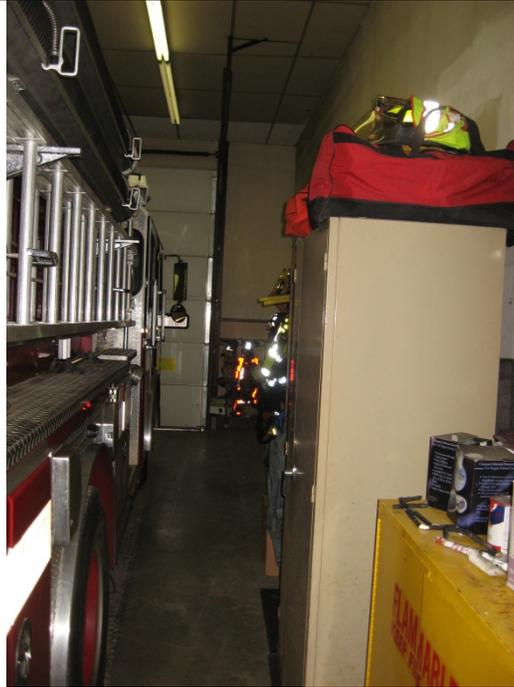
**Photograph 11 -**

Interior view of wall/storage between tanker and engine 1 (engine 1 on left side)

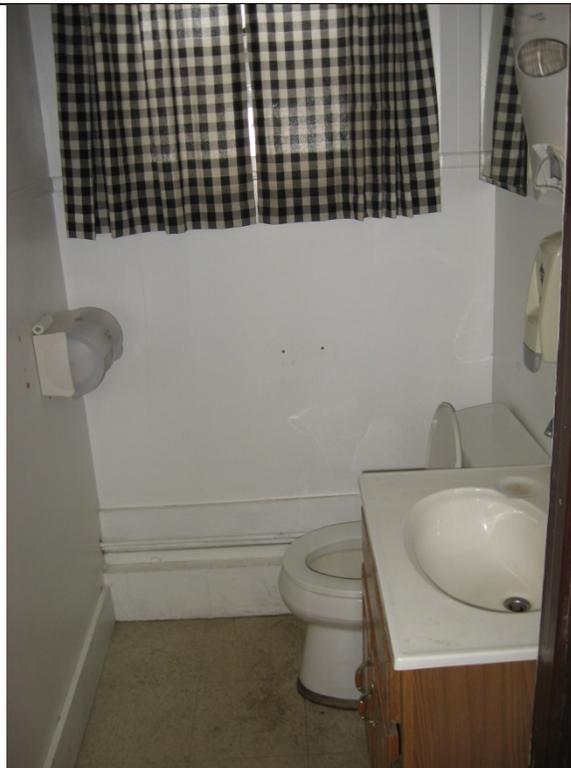
**Photograph 12 -**

Bathroom in apparatus bay. Only restroom in facility located in apparatus bay.

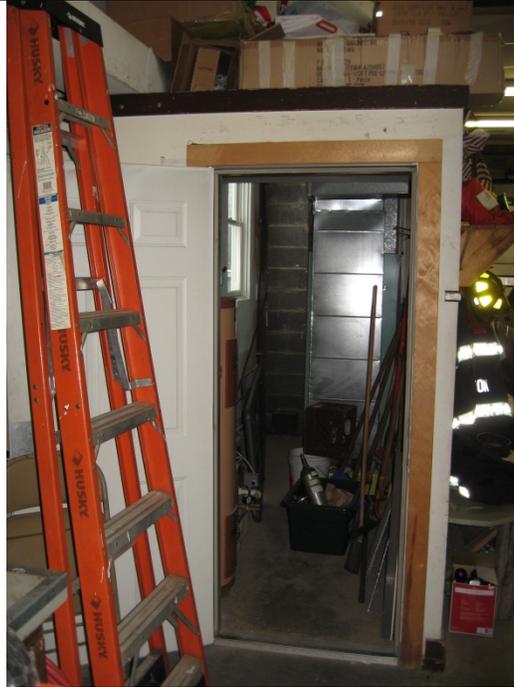
**Photograph 13 -**  
Mechanical room  
beyond

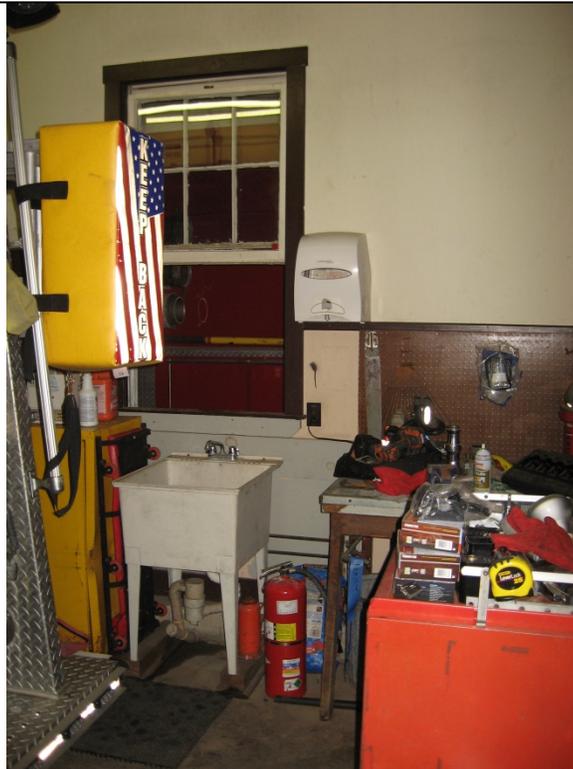
**Photograph 14 -**  
Mop sink and storage  
area behind engine  
1 (tanker located on  
opposite side of  
window wall

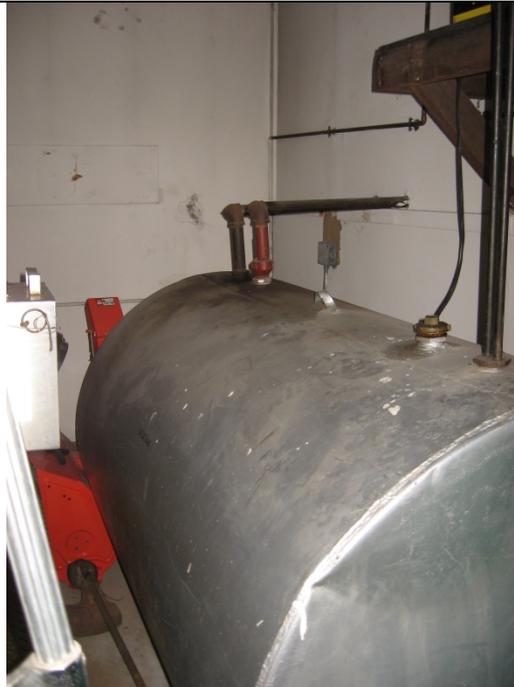
The existing oil furnace is rated at 1.3 GPH. This works out to be about 180,000 btu/ h. The oil tank for this system is in the rear parking bay and is tightly installed near the wall and sticks out into the bay, making the placement of the truck currently parked there very tight. Care is needed when parking this truck to prevent the truck from backing into the tank and causing damage. Speaking from a practical frame of mind, this is a potentially hazardous situation.

**Photograph 15 -**  
Fuel storage tank  
behind tanker

There is also propane currently on site (used for the generator) and this could allow for the changeover to a high efficiency propane furnace for downstairs and allow for the removal of the oil tank and allow for more space in the parking bays.

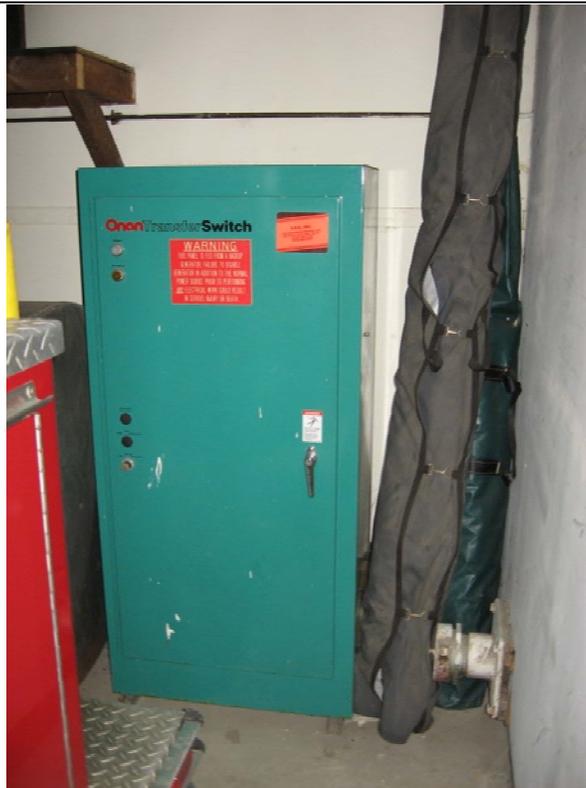
**Photograph 16 -**  
Transfer switch behind  
tanker

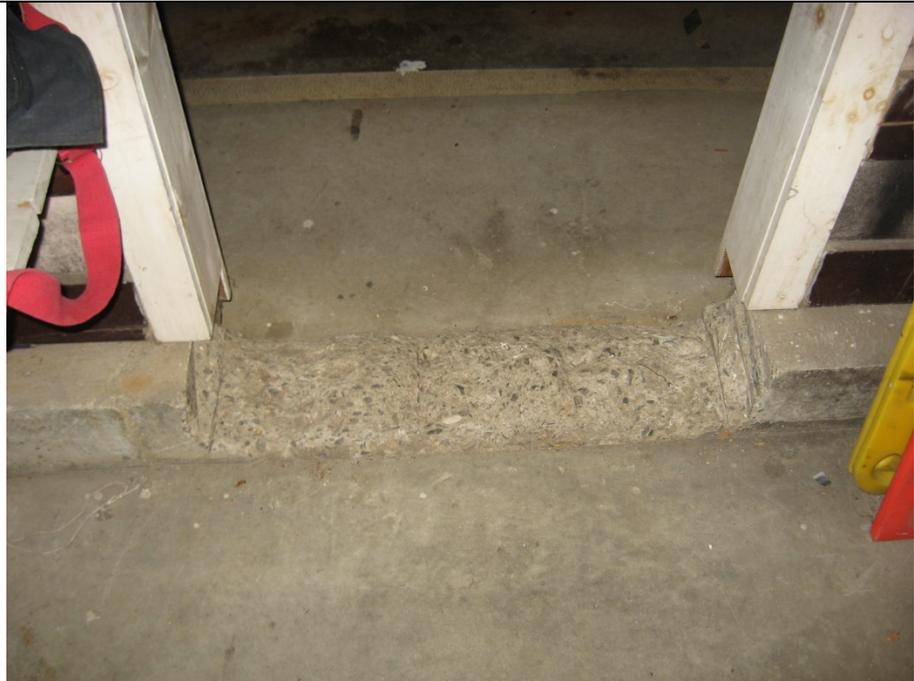
**Photograph 17 -**

- A fuel storage tank and transfer switch is located behind the tanker in the rear apparatus bay (**Photographs 15-16**).
- A wall opening between engine 1 and the tanker allows access to each side from the interior of the building. The concrete curb wall has been chipped down, but is not flush with the adjacent floor surfaces creating a tripping hazard (**Photograph 17**).

Uneven surface/threshold at door between tanker and engine 1

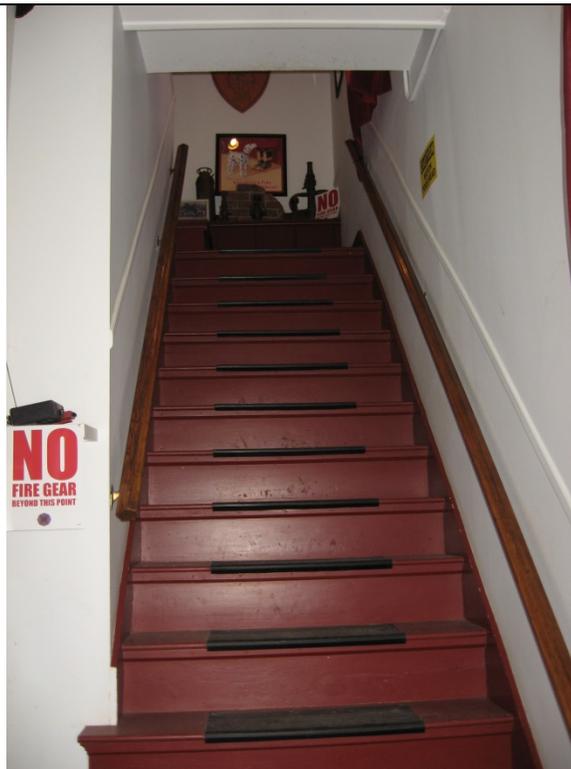
**Photograph 18 -**

- Primary access to the second floor is by means of an internal stair. This stair has a dangerously low head height approximately half way up the stairs (**Photograph 18**).

Stairs up to second floor

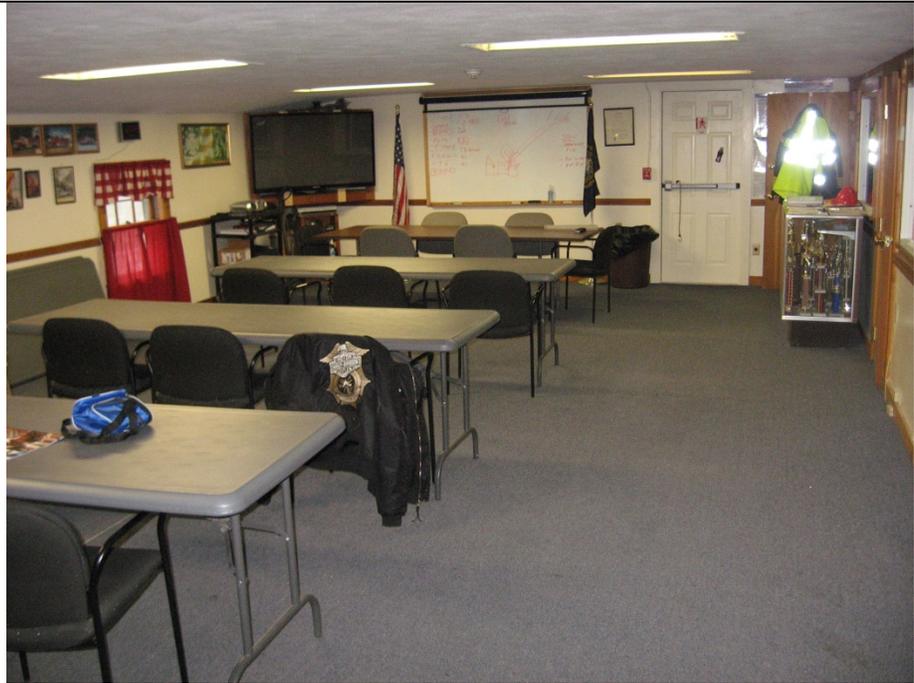
Photograph 19 -

Interior view of second floor (South Main Street) on left side of photograph. Exterior egress door beyond

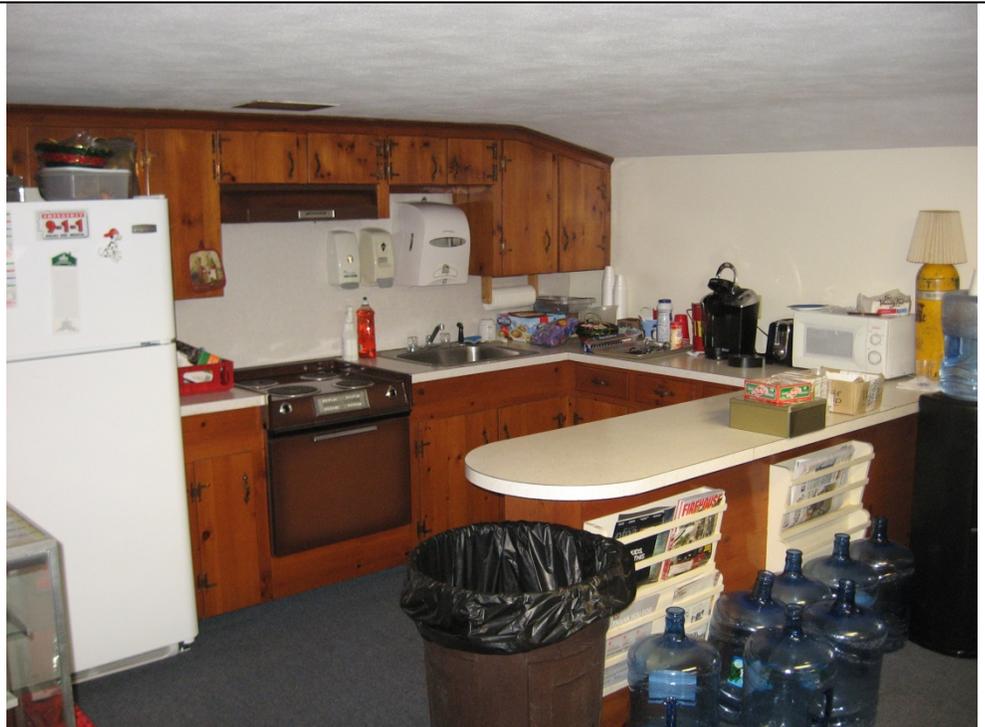
Photograph 20 -

Kitchen area

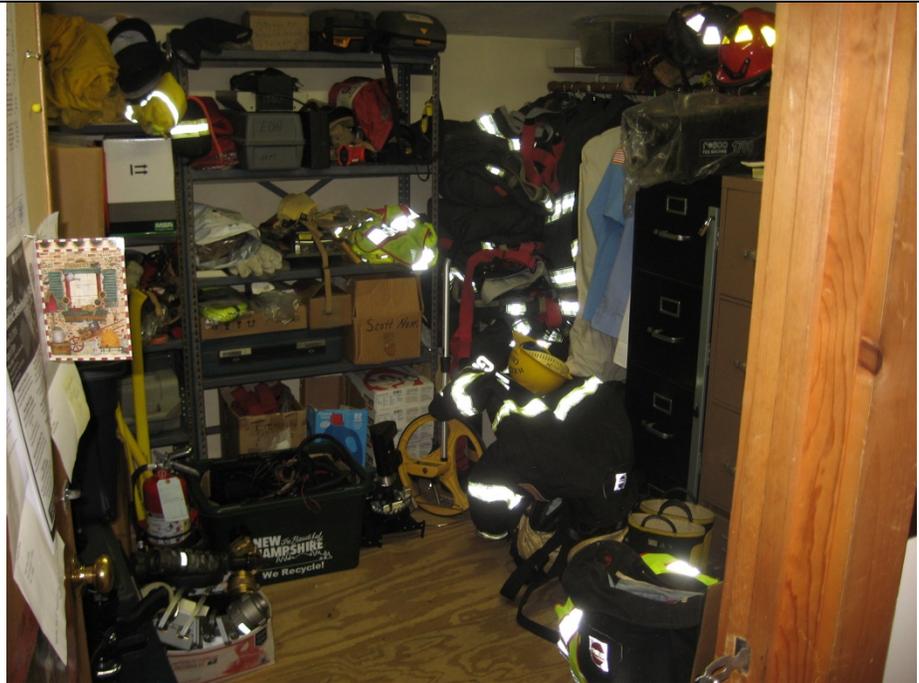
Photograph 21 -  
Storage room at top of  
stairs, second floor

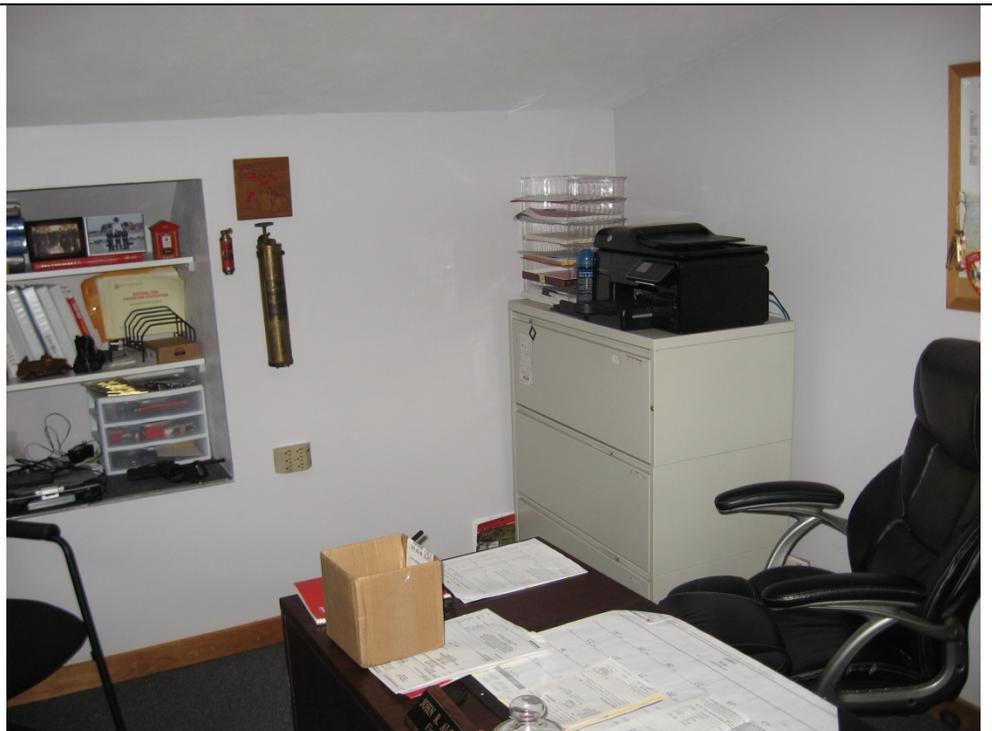
Photograph 22 -  
Second floor office

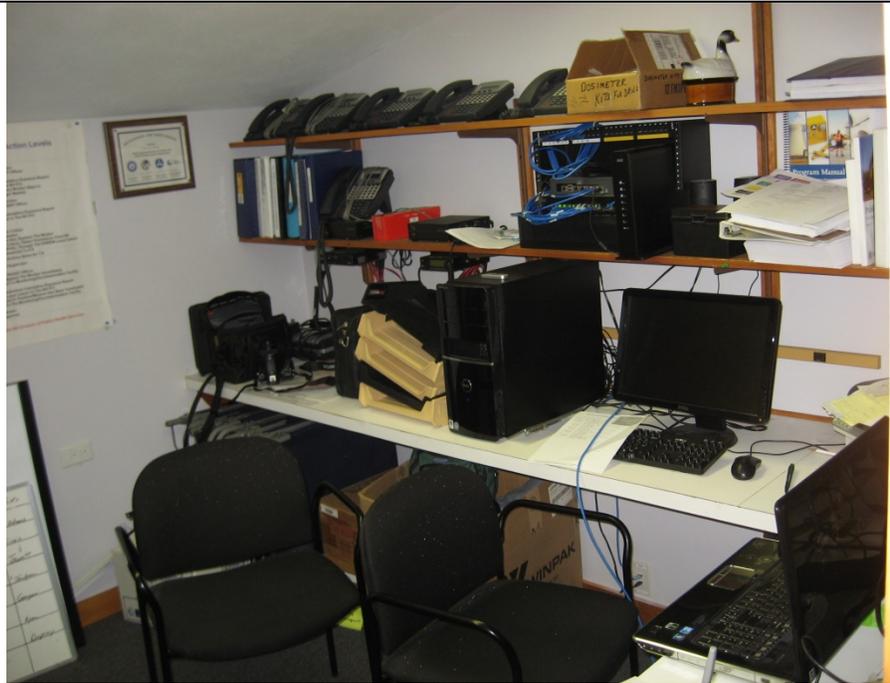
Photograph 23 -  
Second floor office

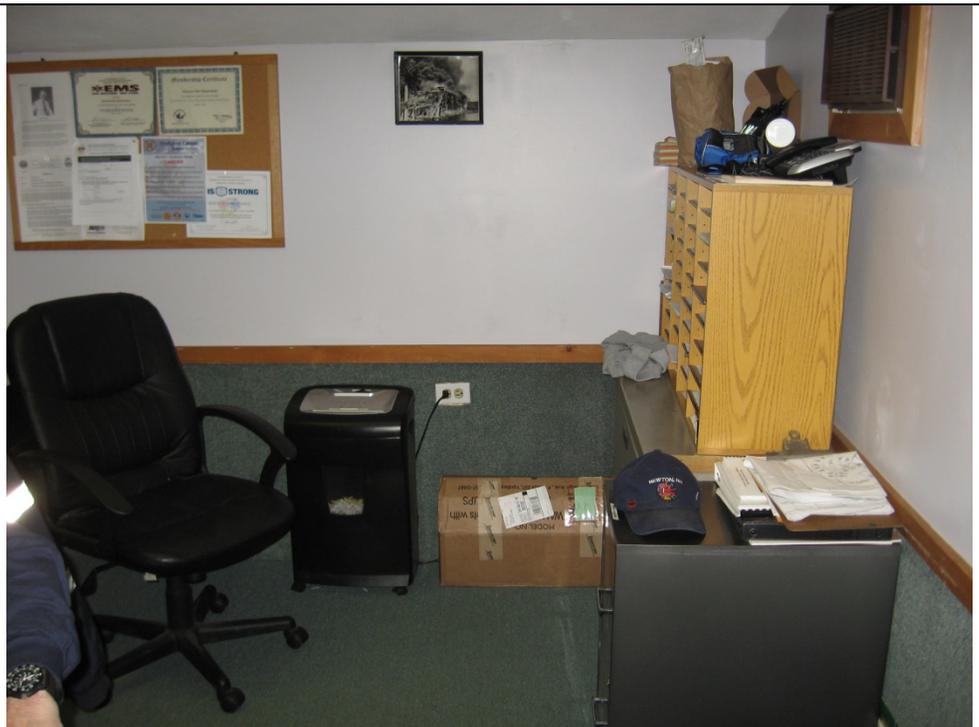
Photograph 24 -  
Second floor office

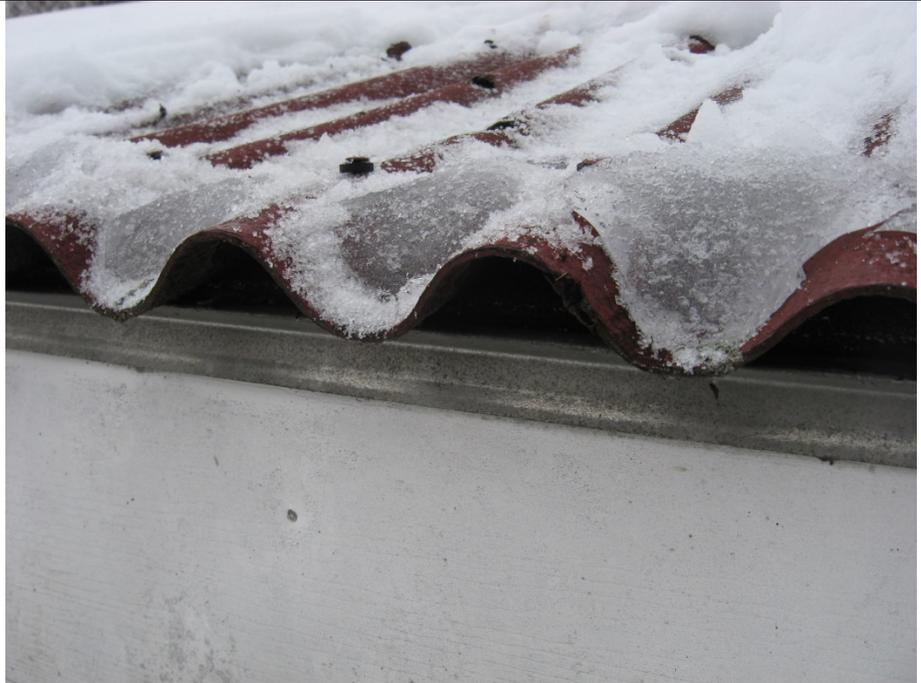
- The roof surface is covered with what appears to be a corrugated asphaltic material over at least one layer of asphalt composition shingles. Roof framing over the rear apparatus bays (tanker & engine 1) consists of open web, metal plate

**Photograph 25 -**  
Rear side roof edge.  
Corrugated roofing  
over asphalt shingles

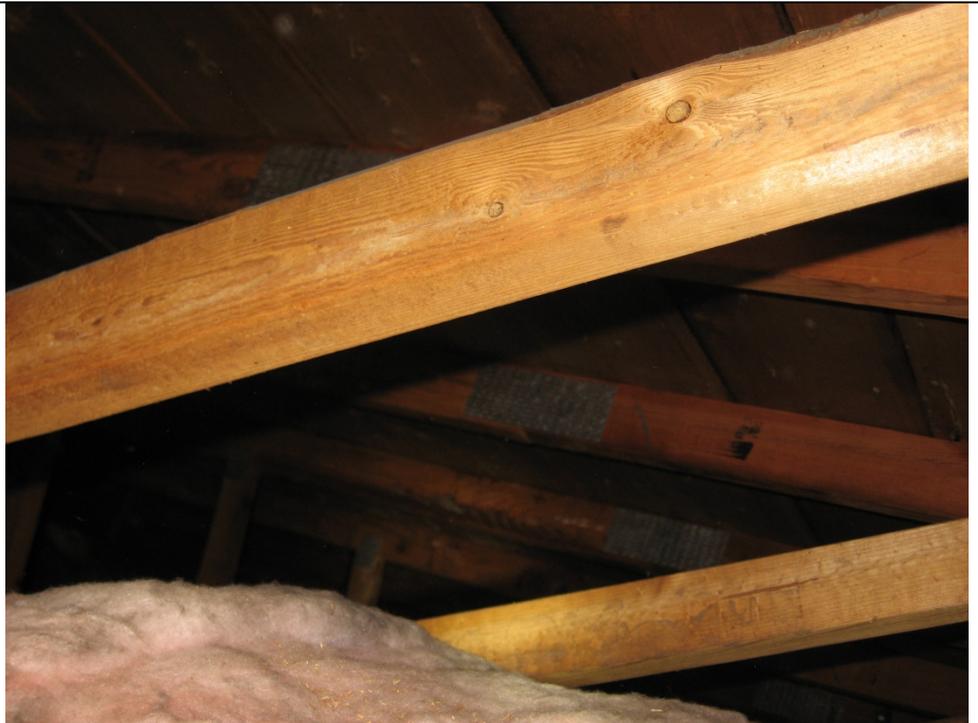
**Photograph 26 -**  
View of attic space  
over engine 1. Metal  
plate connected  
wooden trusses

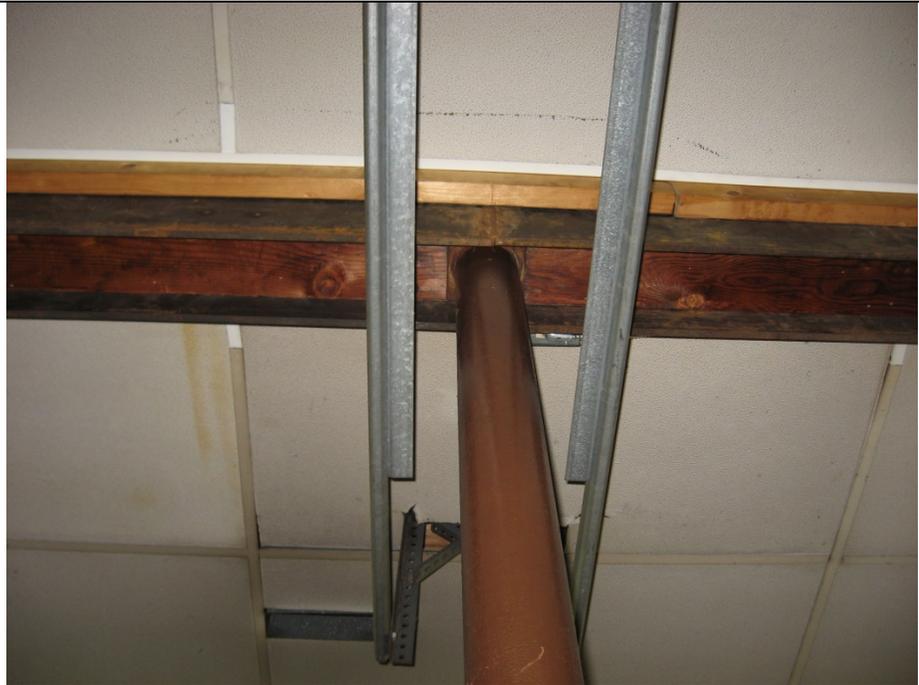
**Photograph 27 -**

Steel plate reinforced  
wooden second floor  
beam in apparatus  
bay

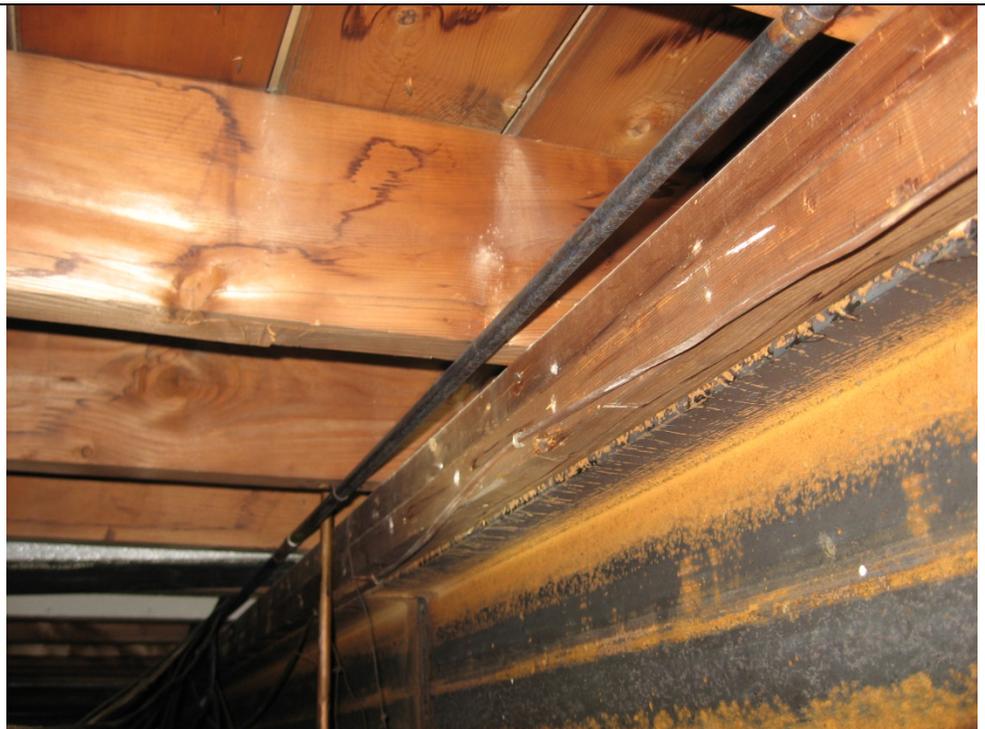
**Photograph 28 -**

2x8 second floor joists  
bearing on steel beam  
at location of steel  
columns along engine  
1

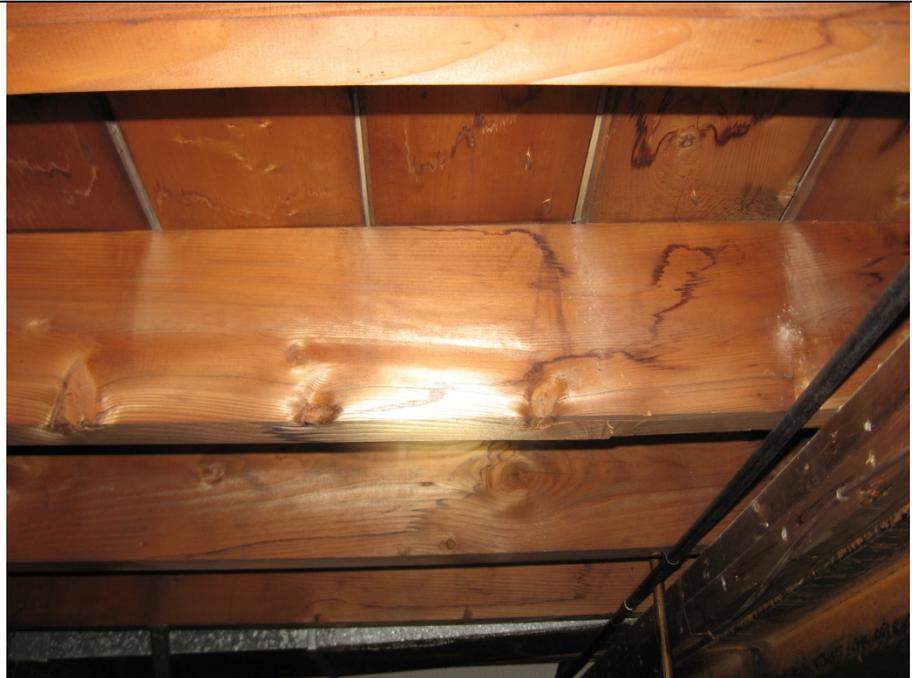
**Photograph 29 -**  
2x8 second floor joists

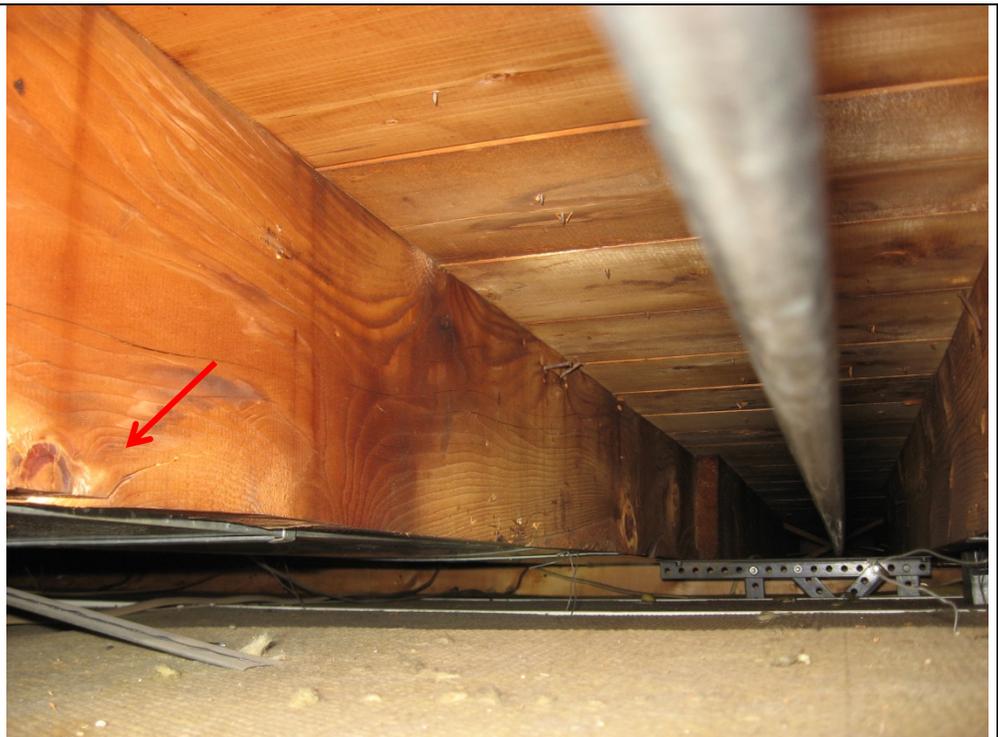
- The second floor framing consists of 2x8 floor joists supported on wood and steel beams. The beams are supported on steel pipe and wide flange steel columns. Minor checks and cracks were observed in the floor joists (**Photographs 27-30**).

**Photograph 30 -**  
2x8 second floor joists  
looking from rear of  
building towards front  
in apparatus bay.  
Note minor crack at  
bottom of joist
