<h1>Newton Safety Complex</h1>	<p><b>Newton Safety Complex Building Committee</b></p>
		<p>Volume I, Issue I 6 February 2007</p>

## Safety Complex Committee Notes

## Status of Safety Services Facilities

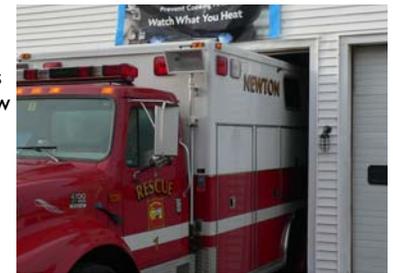
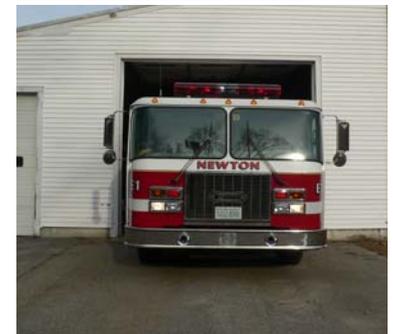
*Trucks have gotten bigger over the years.*

*Note; The Rescue Truck will not fit if there is snow or ice on the ramp.*

*Yes, EI does fit into that bay!*

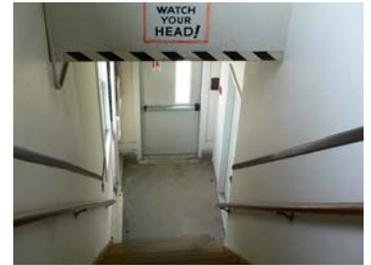
The stairway to the second floor Day Room and offices is steep, narrow and hazardous. The Emergency Management Room and Dispatch Office are not handicapped accessible.

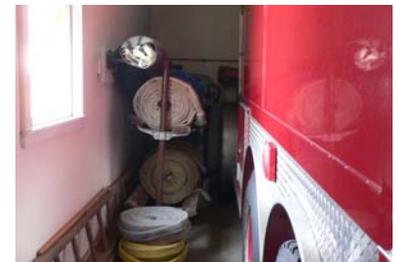
Currently: Hose is stored wherever space can be found to build racks. Often intrudes into space that could be used for safe passage around trucks.

Hose storage is a major problem

Needed: Safe and secure storage areas that allow easy access to hose.

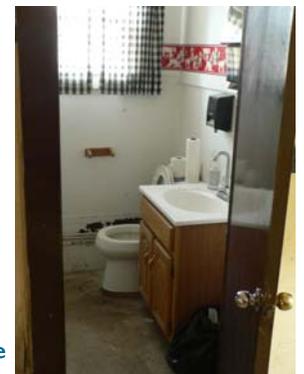
Currently: One common bathroom – hand sink, no shower.

Single "Unisex" Bathroom

Needed: Multiple toilet facilities/code with lavatories and at least two showers.

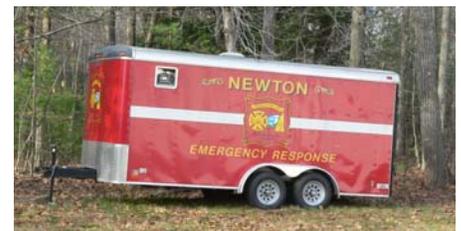
If the HazMat trailer is moved inside it blocks the door to the bathroom.

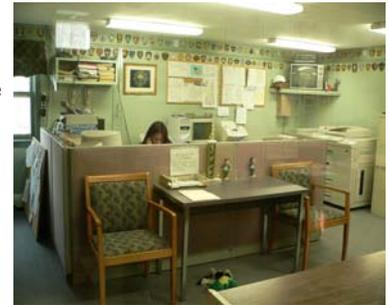
*This space often must serve as Training/Conference Room, Booking Room, and Administrative Area. It is not adequate for any of these purposes.*

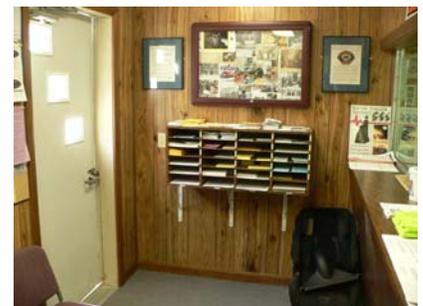
Currently: The current foyer/lobby is very small. There is also not enough room for forms and literature.

*Foyer/Lobby is cramped and has limited space to fill out forms.*

Needed: A large lobby area is needed so that multiple visitors are able to sit comfortably. The lobby should also provide an area for visitors to fill out forms.

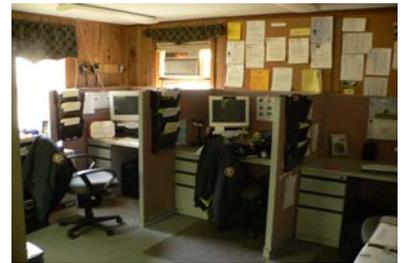
Currently: The current officer's room is 14' x 12' and is extremely cramped. It is the administrative area for 4 full-time and 12 part-time officers and also the animal control officer. It also houses all the department forms, employee bulletin boards, roll call information, and is the main area for information exchange and interviews.

Report Room is also much too small for the work that must be performed.

**Needed:** Additional office space is needed to provide workstations for officers to write reports and conduct private interviews.

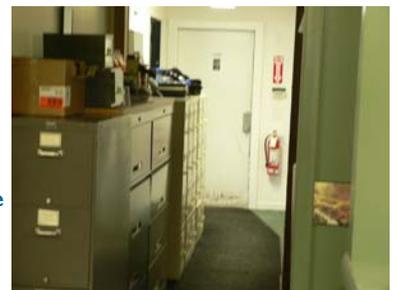
Currently: Department records are stored in file cabinets in a hallway that leads to the main entrance and exit for department employees. Because of these file cabinets, this hallway is left with a clearance space of 2'7" in width. Archived records which must be kept in perpetuity by NH statute are kept in a storage trailer that leaks and has had several files eaten and otherwise destroyed by rodents or other vermin.

Department records files currently reduce the hallway space to just over two and one half feet.

**Needed:** A clean and dry storage area that is easily accessible is essential for proper record retention.

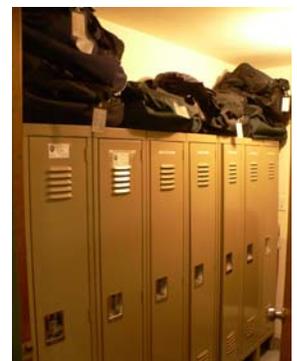
Locker Room

Currently: There is one small locker room that does not have enough lockers for all sworn personnel. There is one shower stall, currently being used for storage.

**Needed:** A larger locker room is needed to provide room for additional lockers, a seating area, and a separate area for female officers.

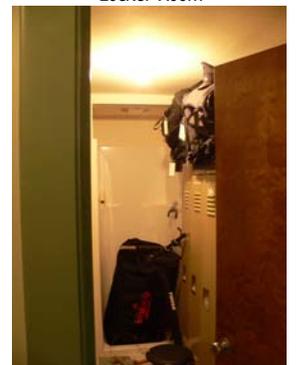
Shower also serves as storage area.
